Draft Environmental Statement

Appendix 10B Site Visit Photos

- 1.1.1 This appendix accompanies the Draft Environmental Statement (ES) for the proposed Trecelyn Wind Farm (the 'Proposed Development') located approximately 1.5km to the East of Newbridge. It provides a record of site survey observations supporting the assessment in **Chapter 10: Water Environment**.

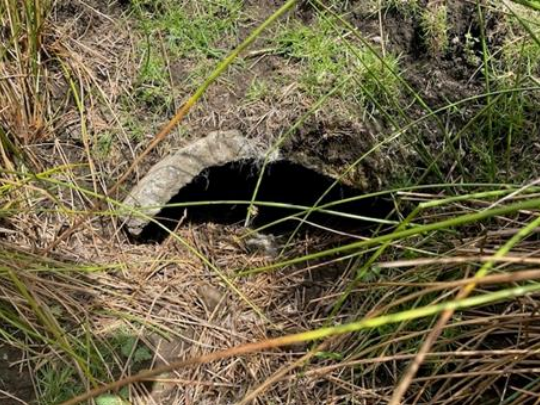
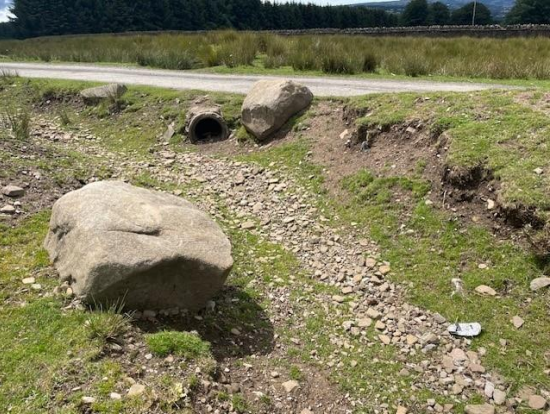
Photos	NGR	Description
 	ST 23611 98000	<p>Existing crossing of tributary of Nant Gawni</p> <p>(WC2 on Figure 10.1)</p> <p>Crossing is within northern land parcel of the Proposed Development on the main access track.</p> <p>Culvert and surrounding ditch were dry.</p> <p>Pipe culvert is approximately 40cm in diameter. First figure is the eastern side of the road and second is the western side. Culvert is partly collapsed on the western side.</p>

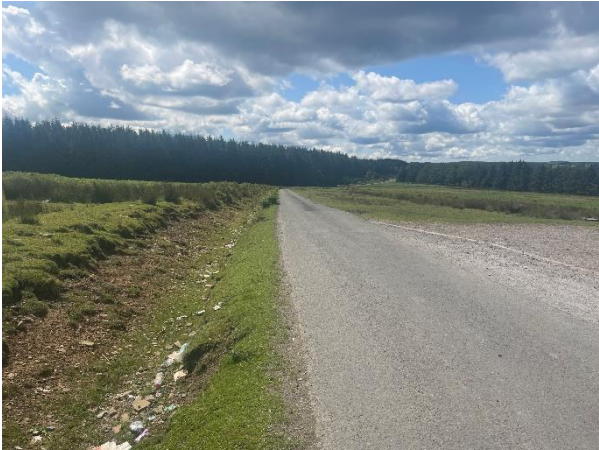
ST 23629 97771	<p>Existing main access road</p> <p>Gentle slope from the Northern land parcel to the Southern Land parcel. Ditch running parallel to the access road on the eastern side.</p>

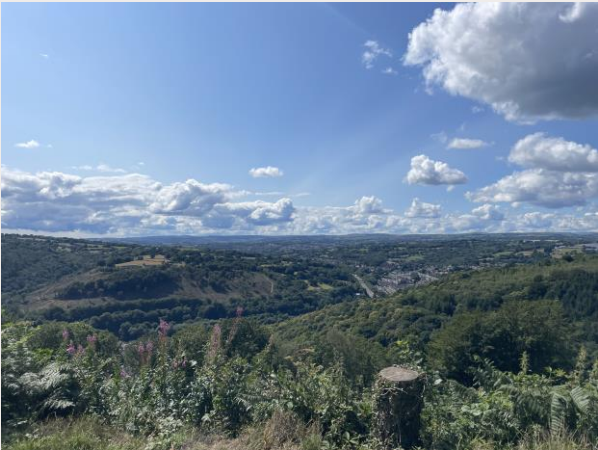
ST 22443 96168	<p>Topography of the wider study area</p> <p>Steep downwards slope to the north west of the Southern land parcel. At the base of the slope is Hafod Quarry.</p>
